Technical Bulletin

60G Paper Roll Clamp Arm and Cylinder Head End Pivot Pin Service Kits

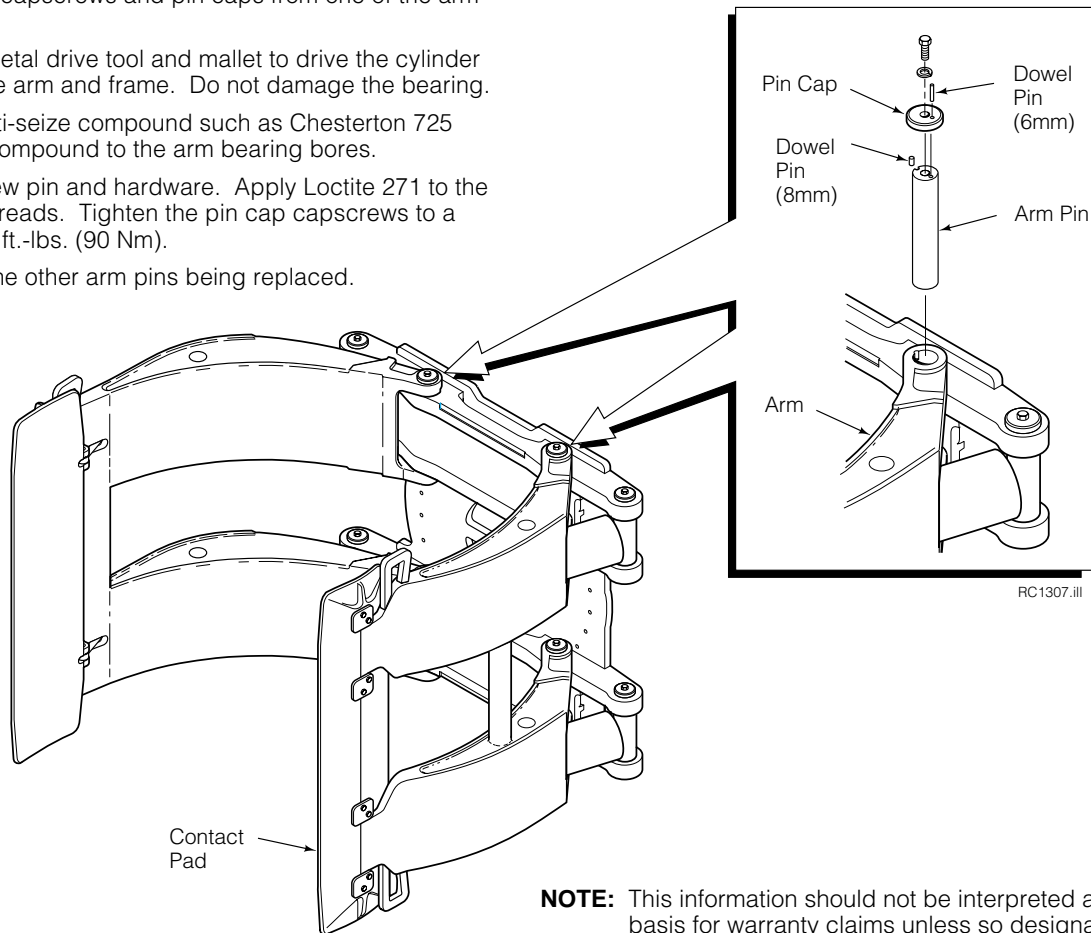
Arm Pivot Pin Kit 6025243

If 60G Roll Clamp frame or cylinder pins are seizing, the problem can be corrected by upgrading the arm and cylinder head end pivot pin assemblies to the latest design. Also, if the pin cap is being replaced, it is recommended that the pin assembly be upgraded. This bulletin describes the installation of pivot pin service kit (6025243) for the arm and cylinder head end pin service kit (6025244). A service kit includes one pin and related hardware.

- 1 Lower the attachment so the contact pads are just touching the ground.
- 2 Remove the capscrews and pin caps from one of the arm pivot pins.
- 3 Use a soft metal drive tool and mallet to drive the cylinder pin out of the arm and frame. Do not damage the bearing.
- 4 Apply an anti-seize compound such as Chesterton 725 Anti-Seize Compound to the arm bearing bores.
- 5 Install the new pin and hardware. Apply Loctite 271 to the capscrew threads. Tighten the pin cap capscrews to a torque of 66 ft.-lbs. (90 Nm).
- 6 Repeat for the other arm pins being replaced.
